## SUCCESSFUL MANAGEMENT OF MANDIBULAR FRACTURES IN DOGS: A REPORT OF TWO CASES

**Abstract:** Two non-descript dogs of different age groups presented to the SVVU Super Speciality Veterinary Hospital, Visakhapatnam with a history of unilateral mandibular fracture due to road accident. Clinical examination revealed that the physiological parameters and hemato-biochemical parameters were within the normal range. Radiography revealed fracture of mandibular symphysis and cranial third of horizontal ramus between right canine and 1<sup>st</sup> premolar teeth in one dog and fracture between right 1<sup>st</sup> and 2<sup>nd</sup> premolar teeth in another. They were treated with interfragmentary orthopaedic wiring under general anesthesia. Both dogs were recovered within a week and no complications were recorded under follow up period of eight months.

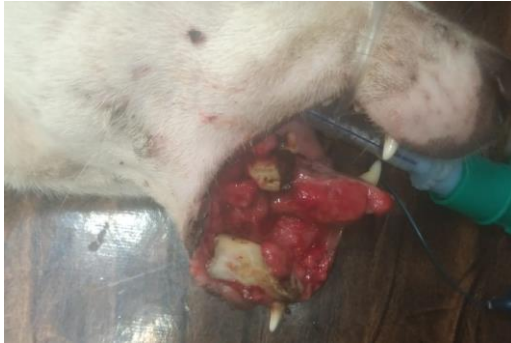
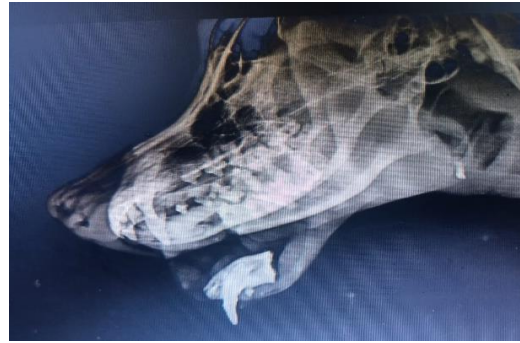
**Fig.1**

Case 1: On clinical (Fig.1) and radiographic examination (Fig.3) under sedation revealed fracture of mandibular symphysis and cranial third of horizontal ramus between right canine and 1<sup>st</sup> premolar teeth.

Fig.1&2. Fracture of horizontal ramus and mandibular symphysis (Case 1)

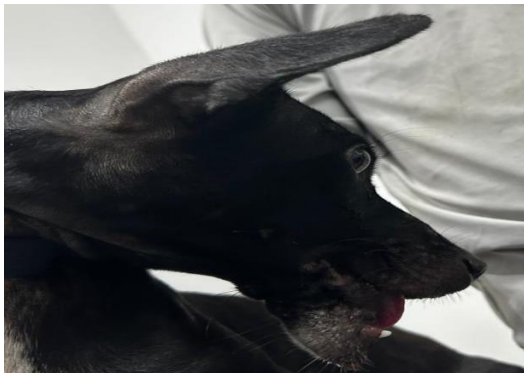
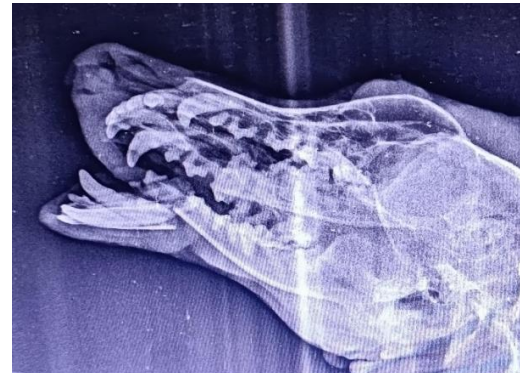
**Fig.3**

Case 2: On clinical (Fig.3) and radiographic examination (Fig.4) under sedation revealed fracture between right 1<sup>st</sup> and 2<sup>nd</sup> premolar teeth.

Fig.3&4. Fracture of mandibular symphysis (Case 2)

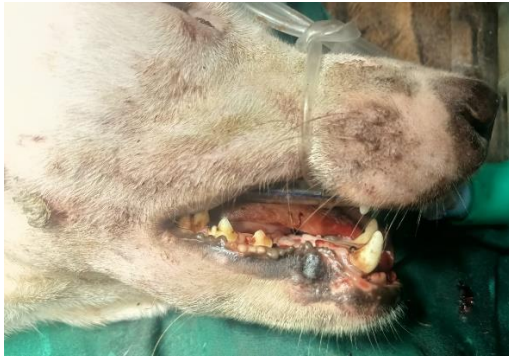
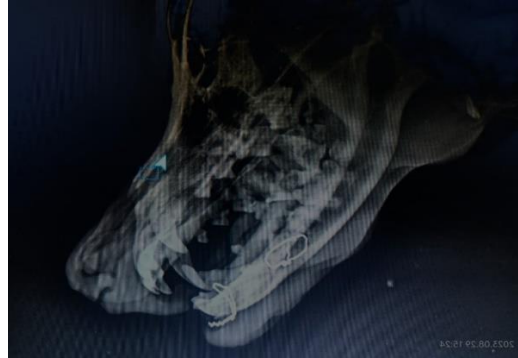
**Fig.5**

Fig.5&6. Alignment of jaws after interfragmentary wiring (case 1)

wire for both the cases (Fig.5,6,7,8). The oral mucosa was sutured using 2-0 polyglactin 910. Postoperatively, the dogs were given tab. Cefpodoxime proxetil @ 10 mg/kg body weight for 7 days and tab. Carprofen @ 4 mg/kg body weight SID for 4 days orally. The dogs were maintained with gruel feeding up to three weeks. Both the dogs were recovered uneventfully without any complications. The wires were removed after 90 postoperative days.

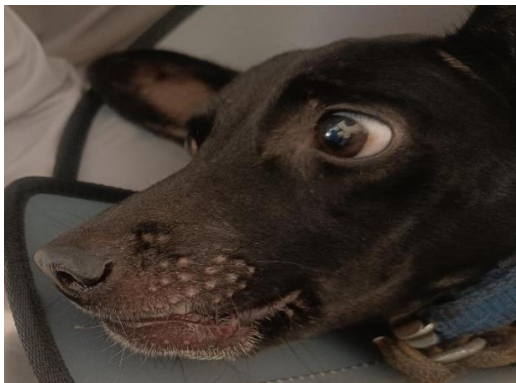
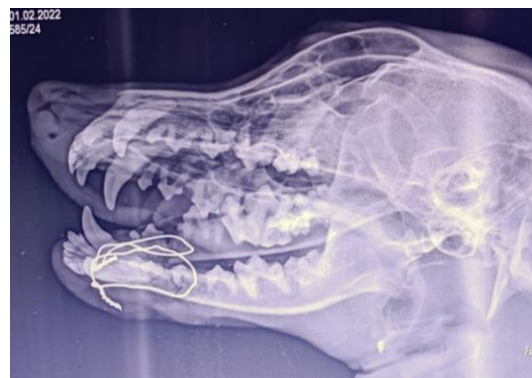
**Fig.7**

Fig.7&8. Alignment of jaws after interfragmentary wiring (case 2)
